DEPARTMENT OF TRANSPORTATION**DIVISION OF ENGINEERING SERVICES**

Office of Structural Materials

Contract #: 04-0120F4Cty: SF/ALA Rte: 80 PM: 13.2/13.9File #: 99.28**WELDING INSPECTION REPORT****Resident Engineer:**Siegenthaler, Peter**Address:** 333 Burma Road**City:** Oakland, CA 94607**Report No:** WIR-024537**Date Inspected:** 06-Jun-2011**Project Name:** SAS Superstructure**OSM Arrival Time:** 1500**Prime Contractor:** American Bridge/Fluor Enterprises, a JV**OSM Departure Time:** 300**Contractor:** Zhenhua Port Machinery Company, Ltd (ZPMC) Changxing Island **Location:** Shanghai, China**CWI Name:** Shi Lei**CWI Present:** Yes No**Inspected CWI report:** Yes No N/A**Rod Oven in Use:** Yes No N/A**Electrode to specification:** Yes No N/A**Weld Procedures Followed:** Yes No N/A**Qualified Welders:** Yes No N/A**Verified Joint Fit-up:** Yes No N/A**Approved Drawings:** Yes No N/A**Approved WPS:** Yes No N/A**Delayed / Cancelled:** Yes No N/A**Bridge No:** 34-0006**Component:** OBG**Summary of Items Observed:**

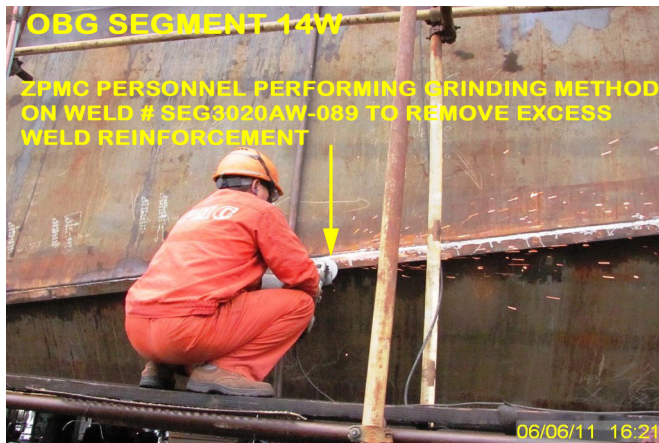
During random in process observations of OBG Segment 14W, this QA inspector observed ZPMC personnel performing grinding method to remove excess weld reinforcement on weld identified as SEG3020AW-089 located on drain plate of the OBG 14W. This QA performed Visual Testing (VT) of the joint and found that appeared to be in general compliance with the applicable contract documents. For more details please see attached photo below:
